Home Performance with ENERGY STAR[®]

Evaluation Report

Customer Name: Sample Report 2
Address of Building: 123 Johnson Street
Mailing Address: Same
City: Madison State: WI Zip: 53704
Phone: (608) 246-1234 Cell: _____
Email: americanconsultantsllc@yahoo.com

Date of Evaluation: 12/05/11
Consultant Name: Robert Runchey
Company Phone: (608) 842-0023
Contractor: Zip Coat Contact: George or Ingmar

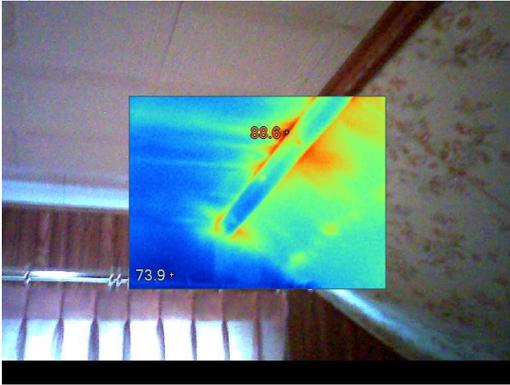
The second floor is particularly leaky and contributing to most of the air leakage and ice damming issues. (photo # 1,1b,1c,1d) The wall and ceiling material is made up of hard board and glue acoustic tile with open seams. This allows a great deal of warm air to enter the attic space. I recommend removing the existing material and replacing it with drywall to build an air tight barrier between the upper level conditioned space and the attic. If the air leakage is not properly repaired and a new roof is installed, ice damming can occur and may damage the new roof to the point of water entering the home, damage the new shingles, and promote moisture related problems.

Photo # 1a
Remove hardboard material and replace drywall

- Remove hardboard and glued ceiling tiles; replace with drywall, tape & joint compound
- Remove insulation from the attic crawl space; block & seal the floors and add closed cell spray foam; add spray foam to the back of the knee walls to R-28

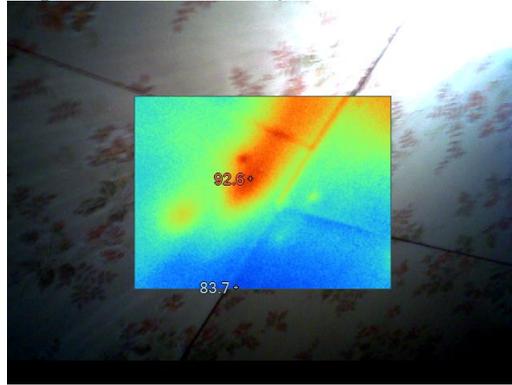
Photo # 1b
Air leakage evident through open seams in sloped walls and ceiling

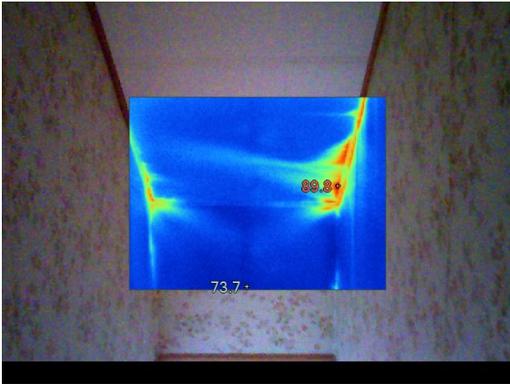
Photo # 1c
Infrared image of air leakage over the top of the stairwell

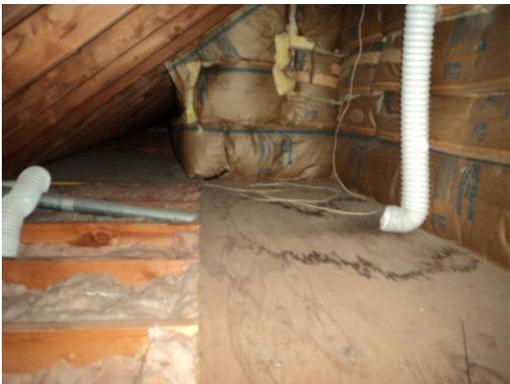
Remove insulation from around interior/exterior top plates, chimney chase, plumbing wall, electrical penetrations, etc. and seal with closed cell spray foam. The knee wall insulation is installed with the face side to the attic crawl space; faced insulation should be installed with the faced side towards the conditioned space to keep moisture from entering the walls and causing moisture & condensation issues. (photo # 2) The bath fan exhaust is also vented into this space and will need to be vented to the outside to avoid moisture problems. (Replace with insulated material) Remove fiberglass batt insulation from the knee walls and air seal with closed cell spray foam to R-28.

Photo # 2
Remove existing batt insulation and air seal with closed cell spray foam. Replace bath fan material with insulated type and vent to the outside

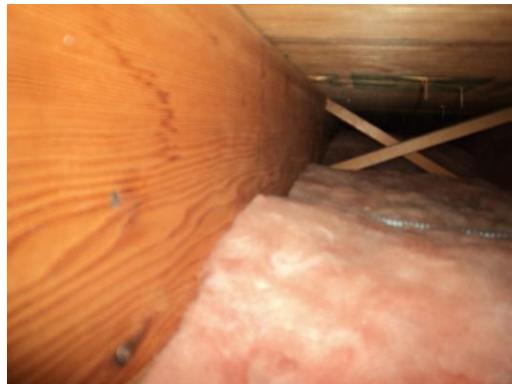
Remove material from the attic crawl space floor; block & seal the floor with insulation stuffed into plastic bags and sealed with spray foam. (photo # 3) Remove fiberglass insulation from the attic floor and add 1-2” of spray foam and cellulose insulation to R-50.

Photo # 3
Block & seal open attic crawl space floor with insulation stuffed into plastic bags and sealed with spray foam

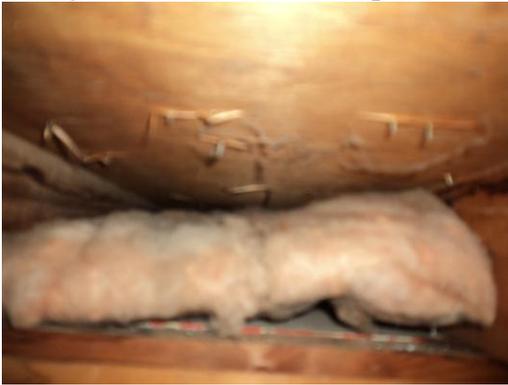
Adding two part spray foam to the sloped ceiling while the roof is being replaced is recommended but is more expensive than fiberglass and cellulose insulation (photo # 4a,4b) but has up to twice the insulating value. (recommended minimal R value for this part of the country is R-49 or better) Add a triangle gable vent to each end of the attic crawl spaces for cross ventilation.

Photo #4a
Add closed cell spray foam to the sloped ceiling when the roof is to be replaced

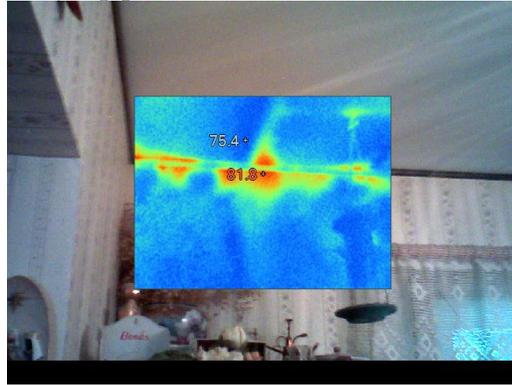
Photo # 4b
Infrared image of air leakage from leaky top plates on the exterior wall

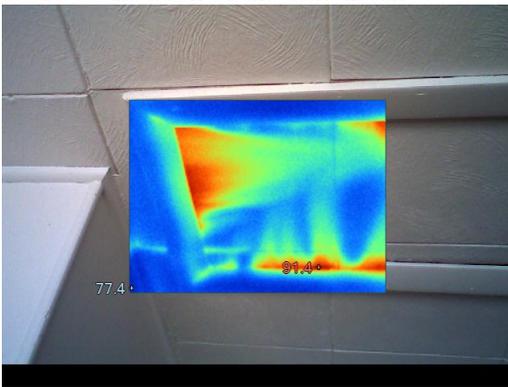
Air seal the attic hatch with weather stripping around the opening and secured with hook & eyelets for a proper seal. (photo # 5) Insulate the back to R-20 using 2” foam board and foil tape. Build a box around the hatch to contain the added insulation; add cellulose insulation to R-50 when all air sealing work has been completed.

Photo # 5
Add weather stripping and ridged foam board to the back of the attic hatch

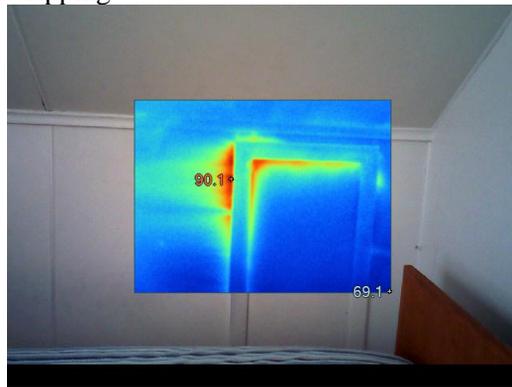
Add weather stripping to the attic crawl space doors to prevent air leakage to the outside. (photo # 6) Remove any fiberglass batt insulation from the sill boxes. Create an effective air barrier by spray foaming along all lengths of the rim joists. Controlling excessive basement moisture can help prevent mold issues, and help control rodents and insect infiltration.

Photo #6
Air seal the crawl space doors with weather stripping

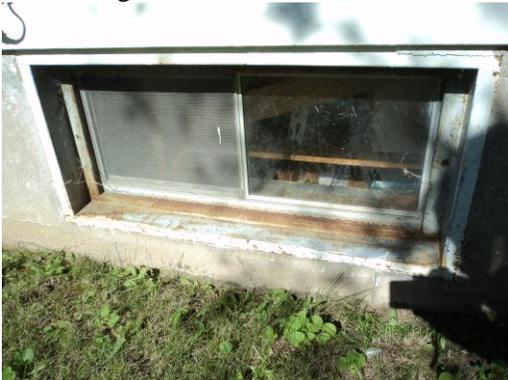
Consider replacing the original single pane glass metal basement windows with insulated sliders or pre-molded glass block with an awning insert for ventilation. Glass block units are not as energy efficient as replacement window but are a good option in keeping out moisture.

Photo # 7
Replace basement windows with insulated sliders or glass block & insert

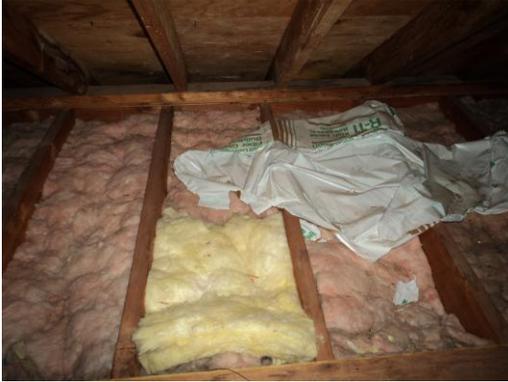
Add closed cell spray foam & blocking to the crawl space floors

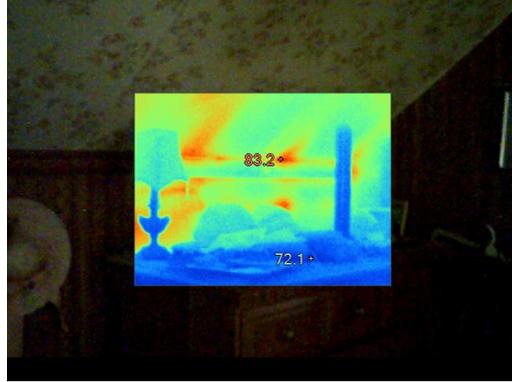
Additional photo of air leakage from the knee wall
